STUDY OF POOR POWER QUALITY IN ZECO DISTRIBUTION SYSTEM

International Conference.
Fostering Cooperation in Energy Efficiency and Accessibility in East Africa
13-14 March , 2017. Zanzibar Ocean Hotel - Zanzibar - Tanzania

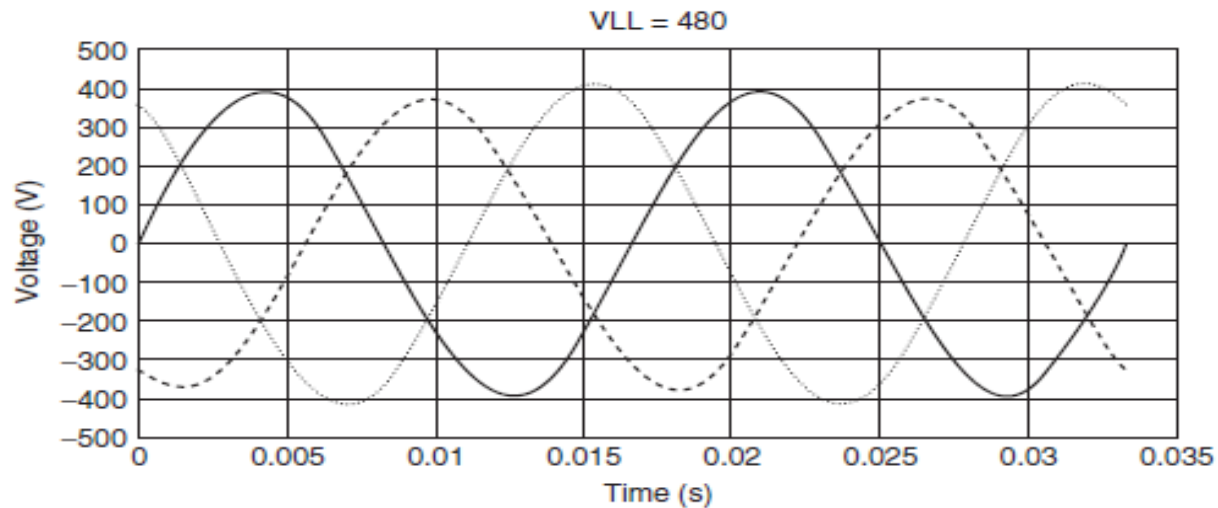
Figure 2: Voltage imbalance wave form

- *Observation:* It is observed that voltage variation in a power system ranges between 0.51% to 9.35%.
- *Causes :* Unequal loads on distribution lines and running a single phase line at a long distance.

- *Voltage Imbalance:* Transposition of transmission line and distribution lines run with three phases and equal load distribution lines for each phases.
- *Undervoltages:* The use of ferroresonant transformer and voltage regulator.
- *Voltage Dip:* The use of constant voltage transformer, voltage dip compensators and dynamic sag compensator.
- *Transients:* The use of surge arrestor, filters and isolation transformer.
- *Overloaded Transformers:* Replacing with higher rating Transformer.
- *Overloaded Transmission Lines:* Replaced with higher rating capacity conductor.

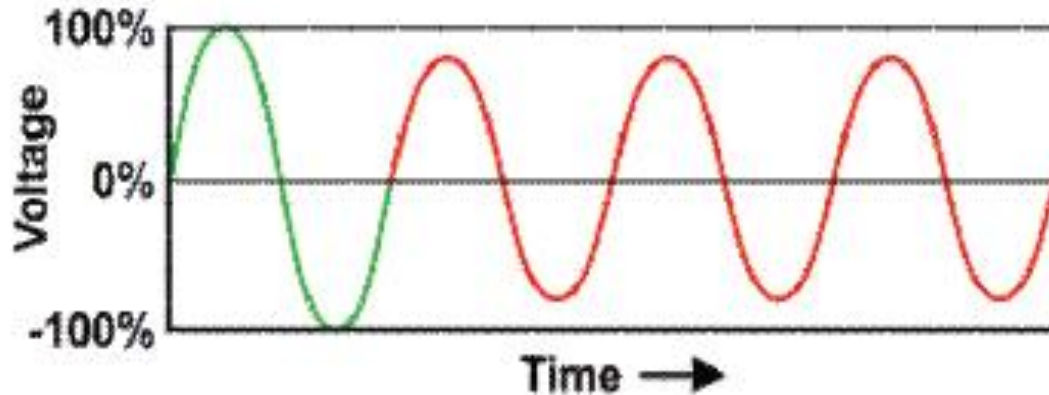
Figure 3: Undervoltage wave form

- *Observation:* The root-mean-square (rms) value deviates at power frequencies for longer than one (1) minute, with the magnitudes range from 78.52% to 90%.
- *Causes:* Heavily loaded circuits that lead to considerable voltage drop.

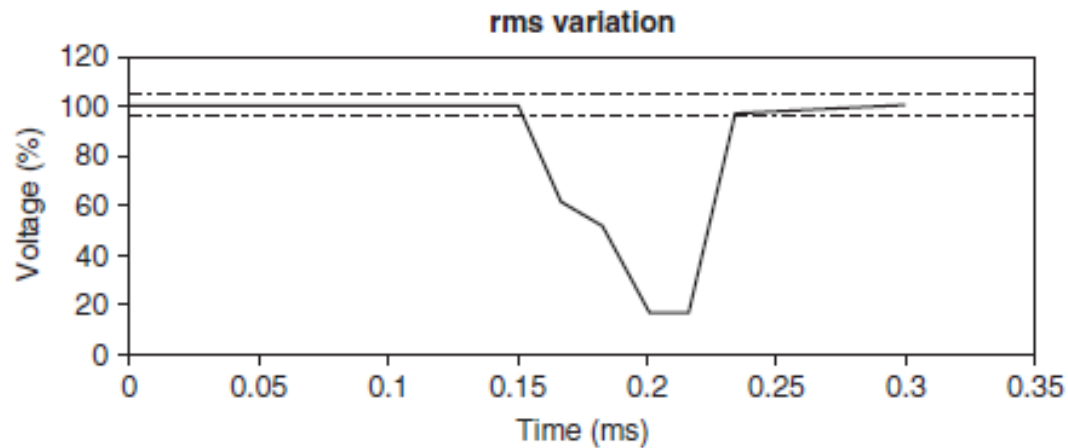
Figure 4: Rms value of sag

- *Observation:* A voltage *dip* or voltage *sag* observed are from 10 ms to 500 ms with magnitude of 0.25 to 0.89 pu.
- *Causes:* Line to ground fault and accident in power lines such as lightning or falling of trees on the lines.

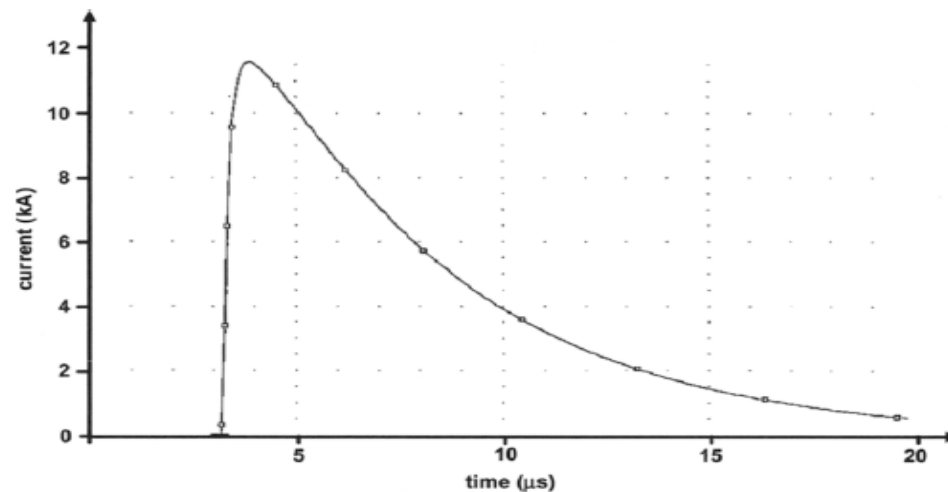
Figure 5: Impulse transient

- **Observation:** Impulse transient with a duration from 2ms to 895ms.
- **Causes:** Lightning.
